Project Example – Remediation of Commercial Vehicle Showroom, Lancashire.

Project Start – February 2012

Project End – June 2012

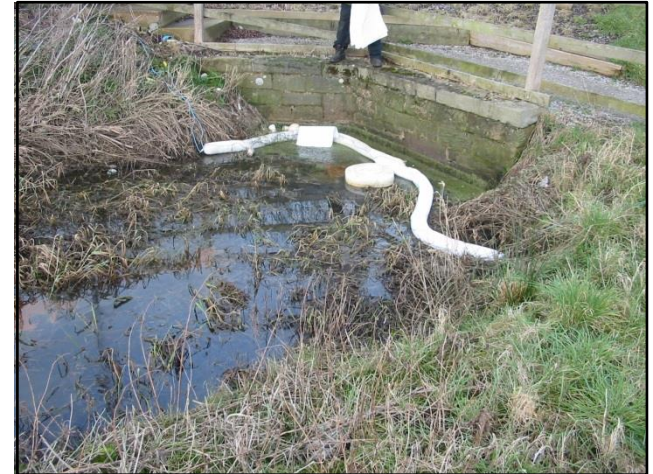
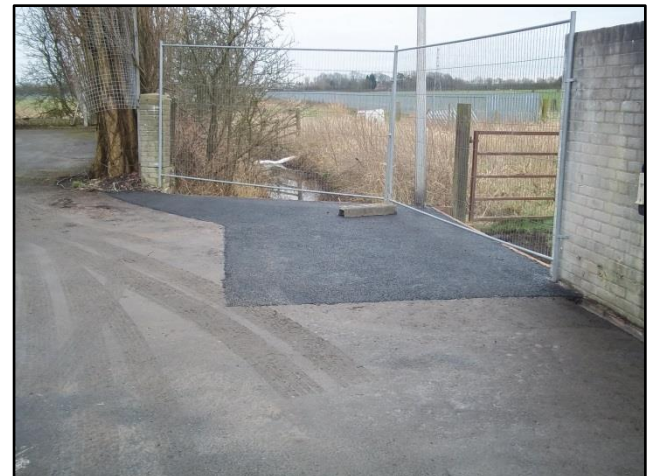
CTSL attended site the same day to protect an adjacent watercourse and to undertake a range of initial actions to prevent further loss of oil. Free oil in the watercourse was removed using a system of floating booms, absorbent booms and absorbent pads. Having completed these initial actions CTSL investigated the nature of the kerosene spill and made costed recommendations for its remediation. After receipt of instructions to proceed, CTSL returned to the property to undertake the remediation. After transferring the remaining oil for off-site re-use, the tank was disconnected and removed from its original location. During removal, inspection identified a number of areas of corrosion, particularly along its base.

After removal of an unstable section of boundary wall and an area of tarmac hardstanding, impacted soils were excavated to depths in the order of 1.5m bgl for off-site disposal. Once the necessary limits of excavation were reached, an assessment of the soils at the base and beyond the limits of the dig was undertaken using a PID. A number of areas of elevated PID readings were detected and additional localised excavation was undertaken to remove these. Once the PID suggested that all impacted soils had been removed, a series of samples were taken from the in-situ soils along all four sides of the excavation and from the base of the dig. These samples underwent laboratory analysis to determine whether any further excavation of contaminated soils was required.

Having successfully validated the excavation, CTSL remained at the property to complete the reinstatement of the remediated area. The excavation was reinstated with primary limestone aggregate, compacted in approximately 300mm layers. At the surface 150mm of tarmac was placed. As agreed with the client, the tank was not reinstalled and the boundary wall was not re-built. Two panels of Herras fencing were fixed to the boundary wall to provide temporary security.
