## Project Example – Remediation of Commercial Nurseries, Lancashire.

Project Start – March 2013

Project End – July 2013

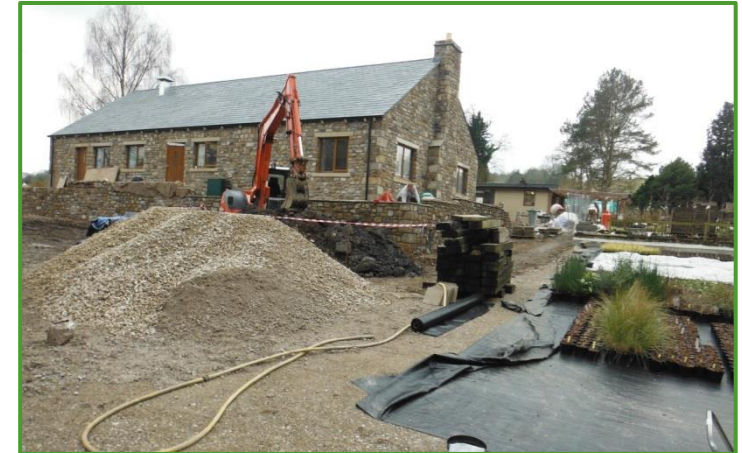
In March 2013, the owner of this commercial property contacted the Environment Agency regarding oil discharging into a watercourse that ran along the property boundary. The property used oil to provide hot water and central heating to a newly constructed stone-built café and the fuel pipe from the kerosene storage tank had been accidentally damaged during these construction works.

The location and extent of the kerosene plume within the insured property suggested that spilt oil had moved into the soils adjacent to the café building and had then moved towards the watercourse where it was able to discharge through land drains and through the retaining wall to impact the controlled waters. An inspection of the retaining wall that divides the property from the watercourse identified two land drains that discharged directly into the beck. In order to protect the watercourse, a trench was excavated alongside the retaining wall, the purpose of which was to intercept and temporarily cut-off all drains and other direct pathways which were allowing oil to reach the beck and to produce a sump into which impacted water would collect. In addition, at points along the banks where oil was entering the watercourse, floating booms and oil-only absorbent pads were placed to collect the on-going discharge. Impacted water from the sump and other locations was pumped through an oil-water separator and a carbon filter vessel. After analysis to show the treated water was uncontaminated and with the authorisation of the regulators the treated water was discharged on site.

CTSL excavated up to 400te of impacted soil from between the spill point and the watercourse, to depths up to 2.4m bgl. Once excavation was complete, soil samples were recovered for laboratory validation. Having successfully validated the excavation, CTSL reinstated the remediated area with quarry-won granular fill, compacted in approximately 150mm layers with a white limestone aggregate finish. All works were completed on budget, to the satisfaction of the property owner and the regulators and to the required timescales.
