Project Example – Small Scale In-situ Chemical Oxidation – West Lancashire.

Project Start – Mar 2012

Project End – June 2012

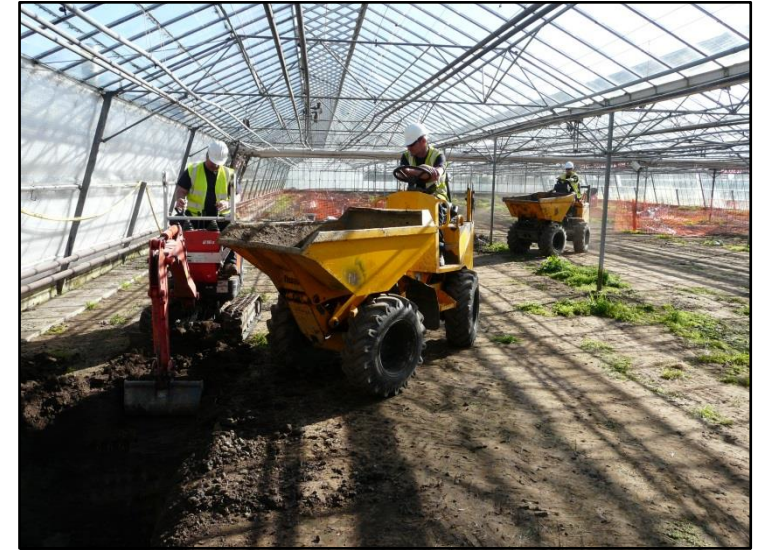
After negotiation with the Environment Agency, the requirements for remediation focussed on the presence of oil-contamination in the system of land drains underlying one of the large greenhouses from which commercial activities at the property were undertaken. On the basis of the intrusive investigation, CTSL concluded that oil from the on-site AST had found its way into the existing site drainage system and had initially discharged to the ditches along the western site boundary. As a result of rising water levels in the receiving waters at the time of the spill, some of the contaminated water had been forced back up the drainage system and entered the network of perforated land drains beneath the impacted greenhouse. This oily water contaminated the gravel surround in which the land drains were laid but also contaminated a zone of natural soils surrounding each drain.

The remediation consisted of a programme of excavation which was targeted at the impacted land drains and the soils that immediately surrounded them. The works were design to avoid having to dismantle sections of the greenhouse. In total approximately 350 linear metres of contaminated land drain, gravel and adjacent soils were removed to a nominal 1m depth and to 1m either side of the drainage centreline. After validation, the excavations were to be reinstated with clean imported soil, of suitable quality for continued commercial horticultural activities at the property. Once the greenhouse was fully reinstated, the elements of the land drain system that had been removed during the remediation were replaced with new land drains and the system reconnected to an appropriate discharge point.
